## PROJECT SUMMARY Isley Elementary School

## PROJECT SUMMARY — ISLEY ELEMENTARY SCHOOL (CONTINUED)

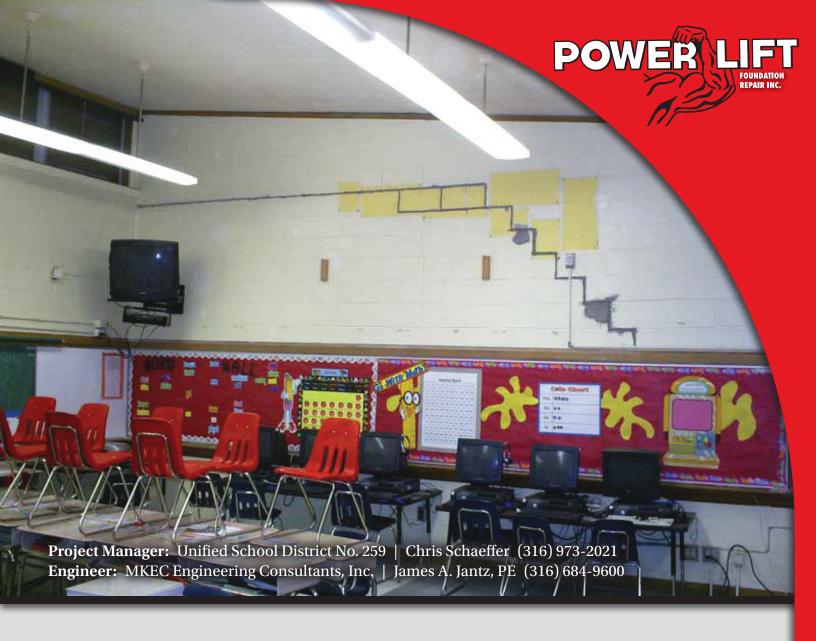
**Project Description:** The inner foundation walls of the school settled over 5" making the classroom doors inoperable and the floors of the hallways to slope severely.

Design Details: Power Lift steel piles were chosen over other foundation repair options because of the ability to produce a synchronized uniform lift. During the design phase of the project, Power

Lift was required to overcome height restrictions for installation of the piles. The subsiding area of the school consisted of crawlspace foundation construction. The height of the crawlspace was 5' from ground level to subfloor. All piles were installed under the floor in the crawlspace area using Power Lift Foundation Repair's patented systems. Power Lift installed 47 piles with ultimate capacities near 100 kips and interlinked them to form a synchronized and unified lifting system.

Once lifting began, complete elevation recovery was achieved, as the foundation was raised more than 5" back to its original position.

The settlement had caused severe damage to the interior block partition walls. Cracks in the block walls closed once elevation recovery had been achieved. As a final step, the cracks were tuckpointed and the masonry restored.

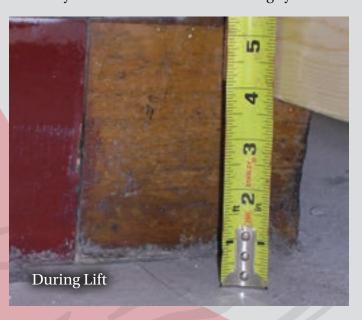
Lifting Process: A  $16' - 2" \times 4"$  was leveled and set across the school's hallway to monitor the floor during the lifting process.

The school was lifted over 5" and the repair work was completed with no interruptions to the operation of the school.
